WEATHERING

ABOUT ACCOYA®

Accoya® is the world's leading high technology wood. It is produced from sustainably sourced, fast growing softwood using a non-toxic modification process from the surface to the core. The result is a durable, stable and beautiful material with the performance characteristics of the most durable tropical hardwoods but with industry-leading environmental credentials.

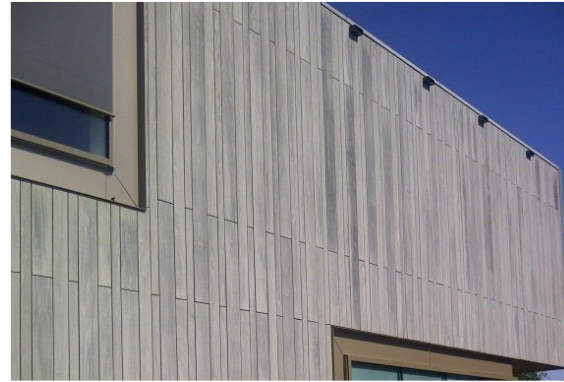
An example of such a blotchy transition period is shown in the image above (Dutch cladding project approximately a year after installation).

However, prior to turning grey, uncoated Accoya will go through a phase of bleaching where it turns a lighter shade of its normal colour. Surface growths are particularly apparent in this intervening period and can vary in level from board to board. This will become less distinguishable and objectionable after full (even) greying, but in this transition period the surface of Accoya may look blotchy.

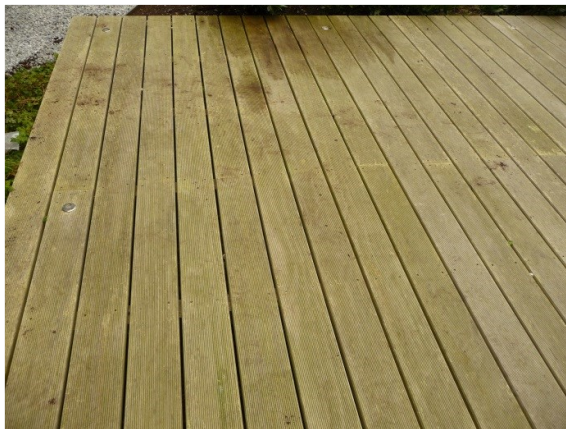
Shaded areas may promote development of algae.

A wet and a dry board may vary in appearance. Due to the installation details, the presence of a shaded area and the natural differences in the wood between boards, as for instance density variation or grain orientation, some may dry quicker than others.

Not only does this reflect on the appearance of a surface while drying, it will also have an influence on the development of moulds, algae and so on.

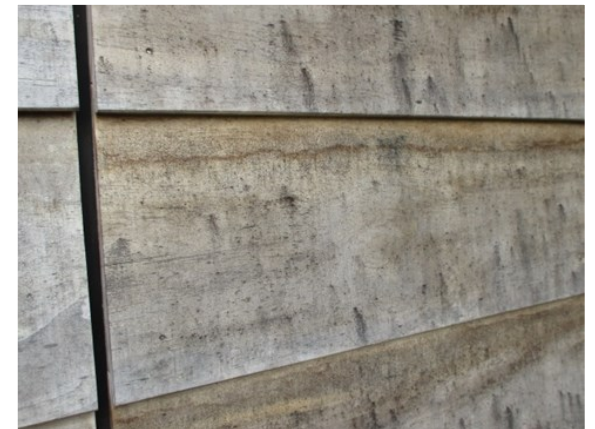
Rough sawn surfaces are more conducive to build-up.

Other influences are location specific, such as proximity to vegetation, pollution and dirt accumulation (rough sawn surface!). Lastly, the natural differences in the wood will also play a role.

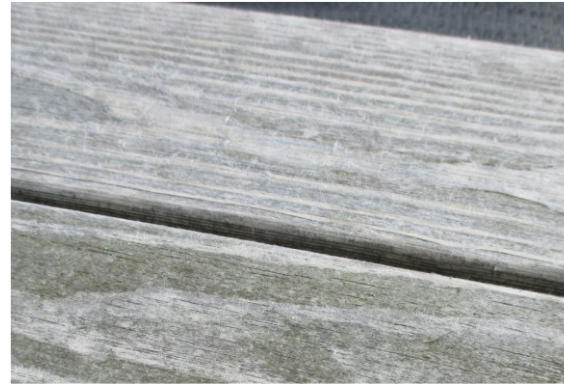
Natural occurring surface fibres on decking.

In addition to that, as explained previously, UV light (which is a part of sunlight) is responsible for partly degrading the lignin in wood surfaces. As this lignin holds the wood cells together, this degradation will lead to a rougher and more open surface. This may be perceived as fine fibres on the surface, which will eventually erode.

The higher the amount or intensity of UV the surface is subject to, the faster this process will develop. It should be noted that these fibres are formed on all exposed wood species, including Accoya, particularly on flat surfaces like decking. A ribbed deck profile will tend to cause an accumulation of these fibres, making it all the more noticeable.

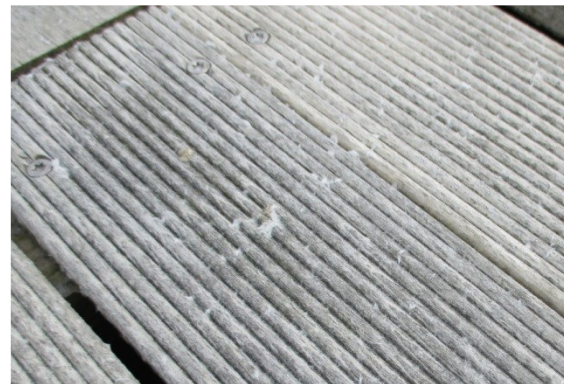
Fibres may get trapped in ribbed surface profiling.

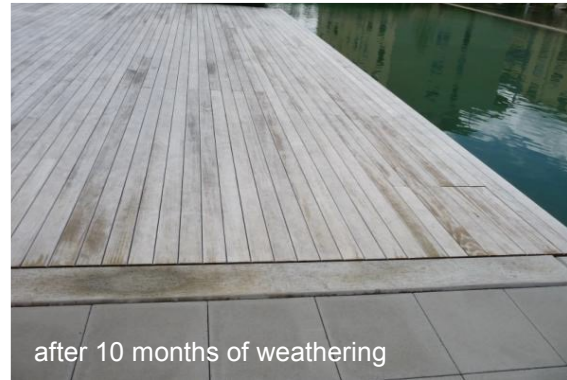
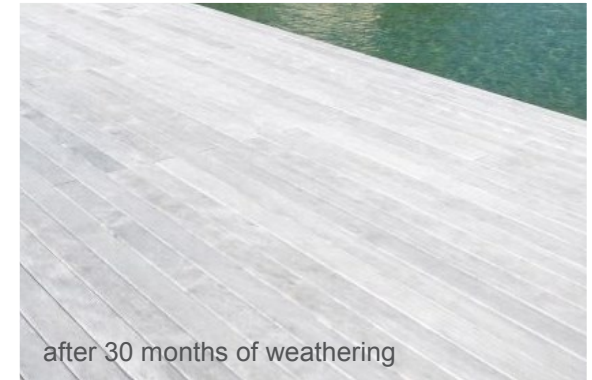
**PUBLIC POOL DECKING,
OESINGEN, SWITZERLAND.**

This deck in Oesingen was photographed when newly installed (left), after 10 months (middle) and after 30 months of weathering (right).

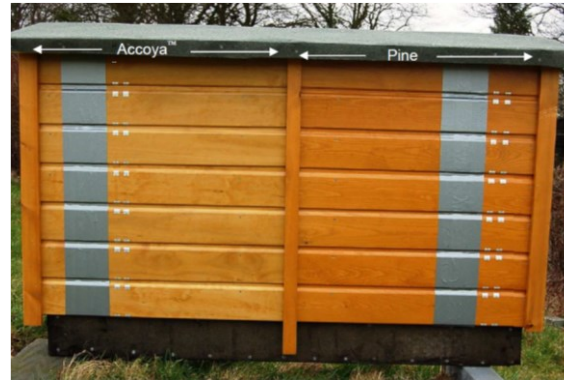
Test set-up at the start of the exposure in February 2008

A south-facing cladding rig was set up at BM Trada for the comparative performance evaluation of Accoya and unmodified pine coated with a semi-translucent stain.

The translucent stain system consisted of a pigmented primer with two topcoats. The cladding boards used were machined to a rebated shiplap profile with the upper edge rounded to a radius of $\pm 10\text{mm}$.
